USER MANUAL: TANKER

RAPID RESPONSE DAMAGE
ASSESSMENT
2024

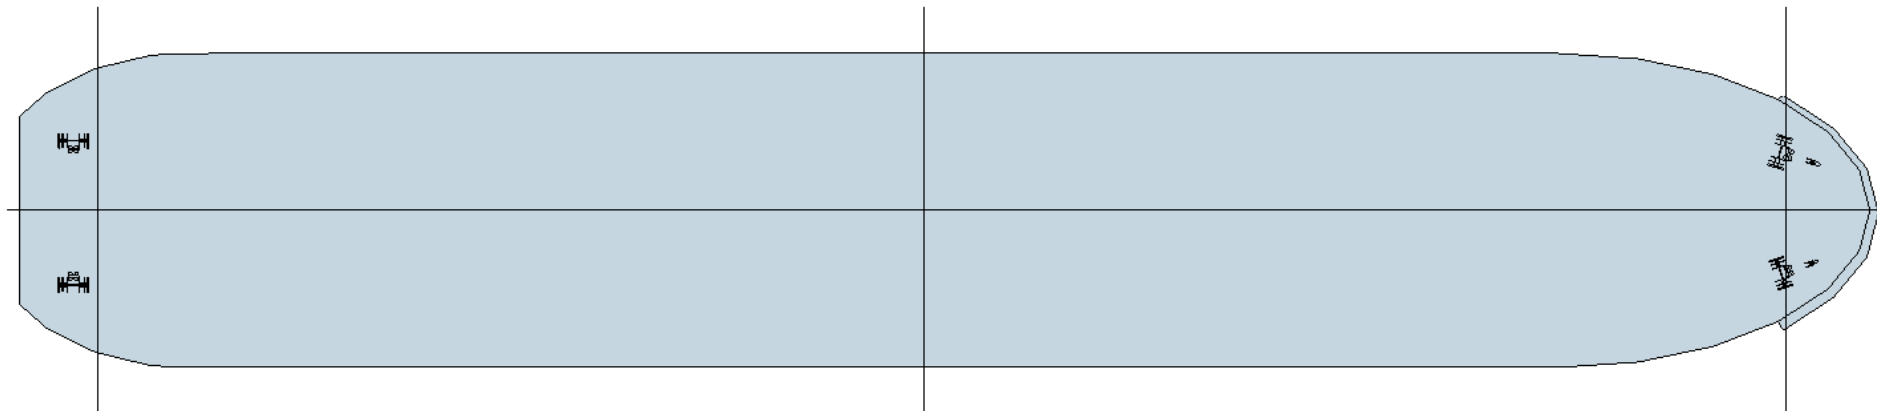
Handy Sketch for Any Incident

USE THIS DIAGRAM TO ILLUSTRATE ANY ADDITIONAL PERTINENT INFORMATION LIKE GROUND CONTACT AREA, PINNACLES, AREA DAMAGED, BUCKLING or CRACKS, HULL BREACH, WATER DEPTHS, FREEBOARDS, DRAFTS, OBSTRUCTIONS, ETC.
